Damage by the 2011 Great East Japan earthquake

Damage by the 2011 Great East Japan Earthquake

Masakatsu Miyajima
Kanazawa University, Japan

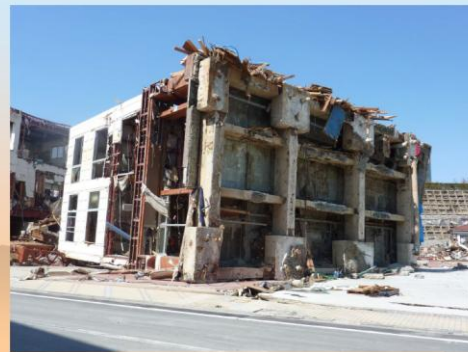
Overturn of building

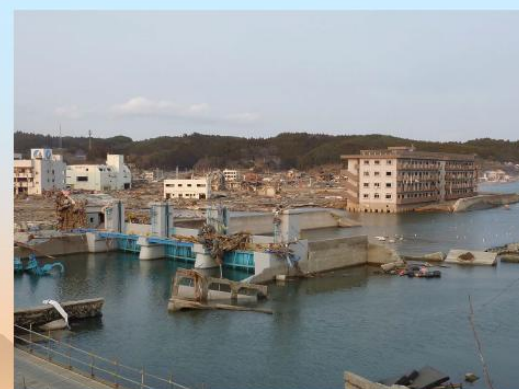
Wash away and overturn of building

Most of RC buildings were not damaged severely even in coast area.

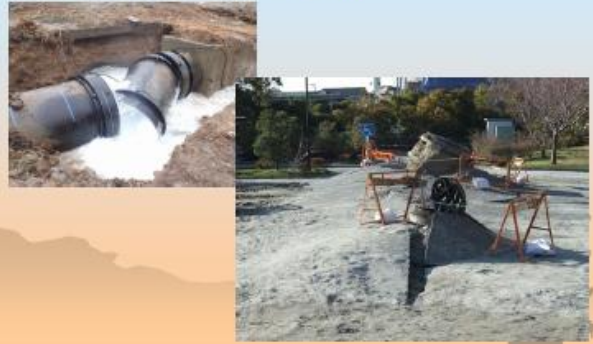
Damage by ground shaking and liquefaction

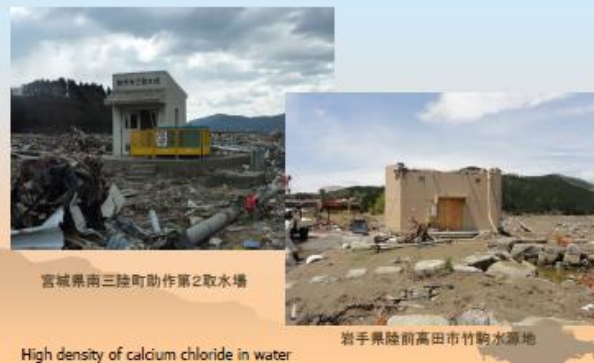
Tsunami (Inundation)

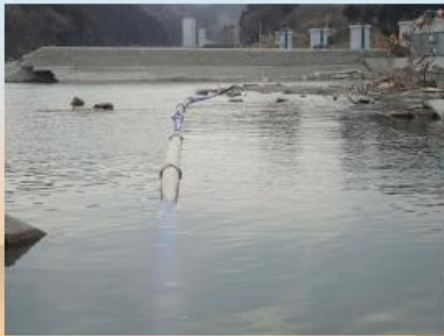
No damage to earthquake-proofing pipe
